# St Mary of Czestochowa

## Project Case Study

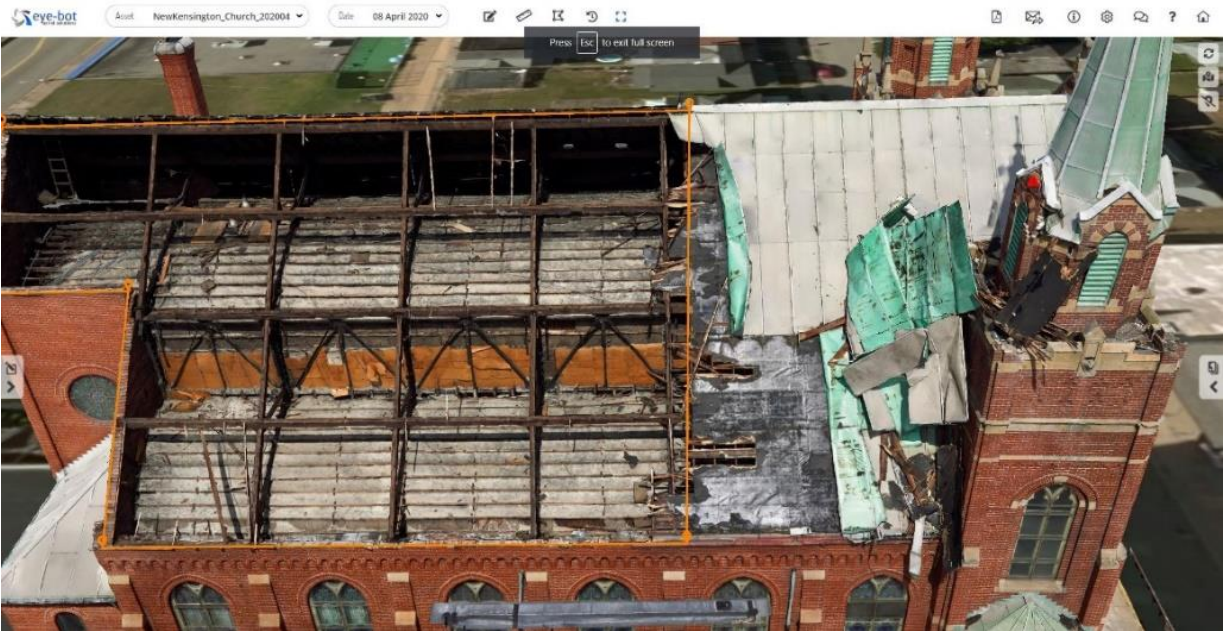
*3D Model capture and processed by Eye-bot Aerial Solutions shown in Trendspek*

The morning after the storm, and in co-operation with the church and emergency response crews, Eye-bot was able to document the post-storm exterior conditions of the church by mapping the area using a survey control network and unmanned aerial system (UAS/drone). Then, by combining the survey data and images gathered by the Eye-bot Aerial Solutions team, an accurate 3D model of the exterior damage was processed and delivered to the church facilities coordinator and other interested parties. **The data was shared in under 24 hours** from capture using Trendspek, a web-based data delivery tool that allows users to measure, collaborate, annotate, and view every image used to create the 3D model.

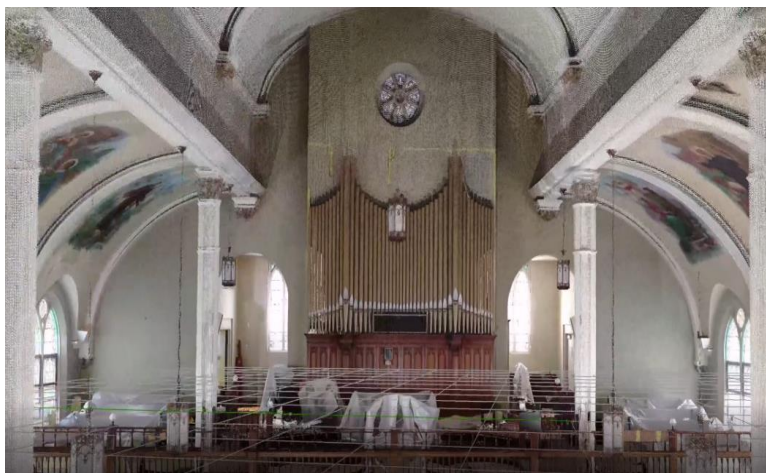
*Interior 3D Point Cloud*

In addition to the exterior data captured via drone, Eye-bot was tasked with interior 3D laser scanning services to properly document the conditions of the church's interior to further assist HDG. Using a combination of traditional surveying and mapping methodologies, along with the 3D laser scanning and drone technologies, Eye-bot was able to provide HDG with **a comprehensive interior and exterior, visual, as-built data set to inform the project without the incurring the exhaustive cost and time of taking unreliable hand measurements for their drawings.**

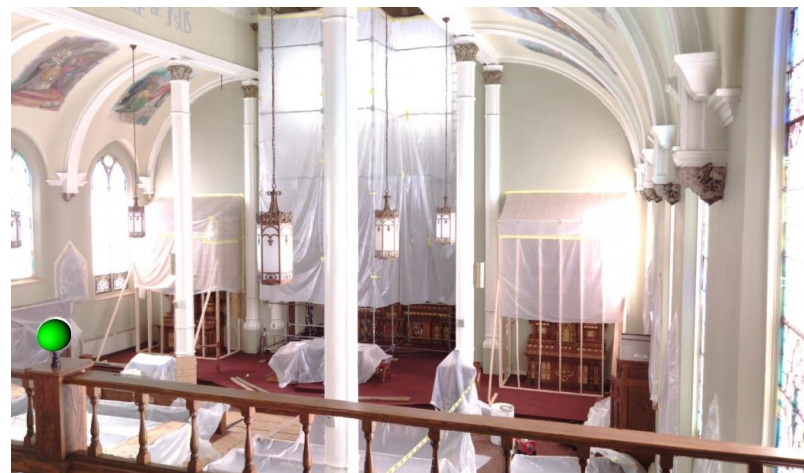
*Interior 360-degree image*

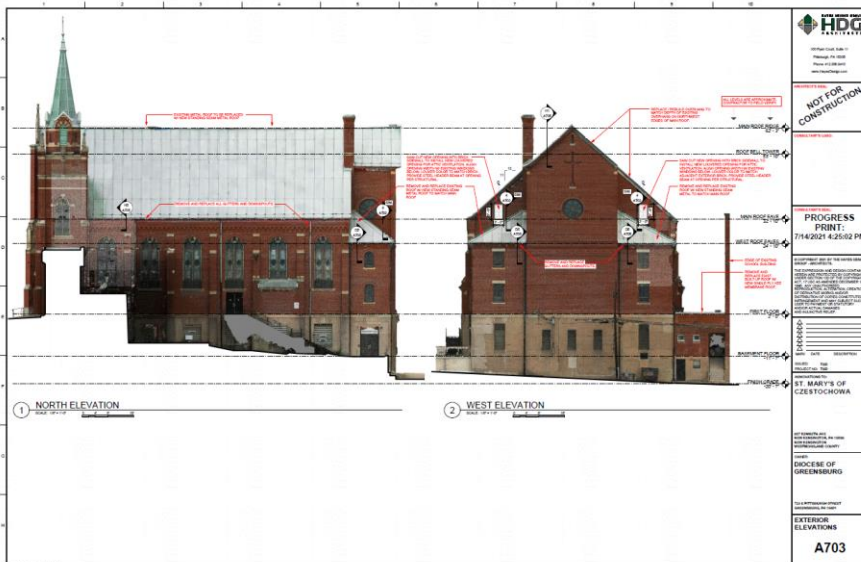
Exterior drawings developed by HDG using Eye-bot data

After a brief meeting between the two companies, it was determined that the exterior data previously collected could be converted into a Revit compatible file which was being used by HDG to develop the proposed drawings for the repair improvements to the Church. Because all of the exterior data had been collected using proper surveying methodologies, HDG could proceed with confidence in having accurate, field-verified, visual data to extract the pertinent elevations and dimensions to assist in the development of their CAD drawings.
